Maintaining Permeable Pavements: Unveiling the challenge through long-term monitoring and forensic engineering

Luis A. Sañudo-Fontaneda^{1,2*}, Daniel Jato-Espino³, Natasa Tziampou^{2,3}, Carlos Rey-Mahía¹, Alicia Martínez-Fernández¹

Clogging, flood resilience, interlocking concrete pavement, porous mixtures, SUDS.

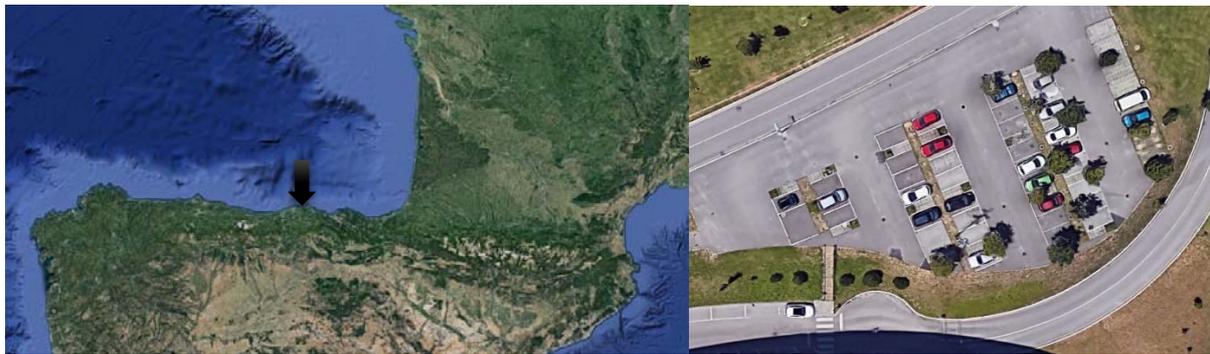
Figure 1. Location and car park scheme (Source: Google Maps).

The car park monitored in this research is located in Santander, a coastal city next to the Cantabrian Sea, Northern Spain (Figure 1). Its Köppen-Geiger's climate classification is Cfb (Essenwanger, 2001), with 15°C of yearly average temperature and 1,136 mm/year of average rainfall (García Couto 2011).

37 out of the 45 car park bays in this experimental parking area (Figure 1) have been monitored for this study over 11 years. The breakdown of these bays is as follows: 9 of PA, 9 of PC and 2 types of ICP (10 of ICP-1 and 9 of ICP-2).

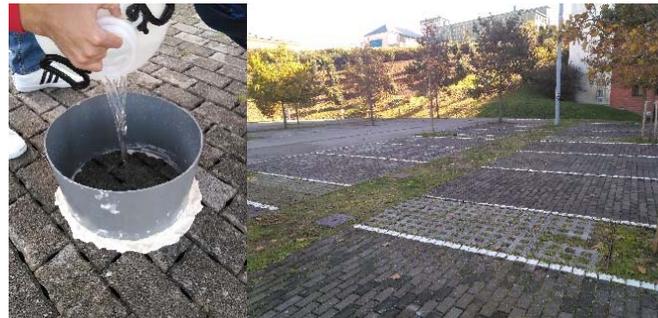
Figure 2. Permeability test ASTM C1781/1781M-15 and view of the ICP-1 and ICP-2 lines.

The car park bays were monitored according to two different standards. On the one hand, the Spanish NLT-327/00 (CEDEX 2000) allows to measure the infiltration capacity of PA surfaces by providing their permeability. This test can also be conducted to determine the permeability of PC surfaces, as proved by Fernández-Barrera (2008) and Sañudo-Fontaneda et al. (2014), having its correspondence with the European Standard EN 12697-40 (European Committee for Standardization 2012). On the other hand, the ASTM C1781/C1781M-15 (Figure 2) and C1701/C1701M-17a Standard Test Methods (ASTM 2015 and 2017) were developed to measure the infiltration rate in ICP surfaces and PC surfaces, respectively, being also used the latest one for PA surfaces. Table 1 shows the different tests carried out throughout the years on each car park bay, presenting the monitoring scheme followed by using standardised permeability tests.

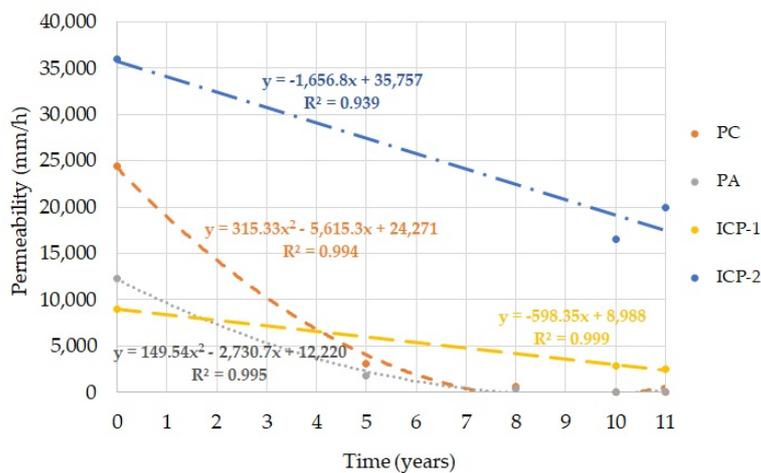
Figure 3. Trend lines for each permeable surface.

Trend lines for the long-term performance were obtained over 11 years of monitoring (Figure 3). The equations for each surface inform about the potential time when maintenance should be carried out for the specific conditions of Santander, Northern Spain. Based upon these trends, both PC and PA surfaces should have been maintained after 6-7 years of performance whilst ICP-1 and ICP-2, would require maintenance activities after 15 and 21 years, respectively, based on the predictive nature of these models. Time to clog has increased for ICP-2 in comparison to what it was found after 10 years in Sañudo-Fontaneda et al. (2018). This supports the idea of keeping a long-term monitoring in order to feed and update the predictive models.

Furthermore, the average permeability values obtained for the ICP-1 surface after 11 years of performance (2,527 mm/h) fit into those reported by Razzaghmanesh and Beecham (2018) in their review on ICP surfaces, and those from Bean et al. (2007). However, the average permeability reached by the ICP-2 surface (19,966 mm/h) was comparable to the values measured after 2-4 years of performance at other locations considered in the previous review. This difference can be explained due to the lack of aggregate materials between the joints in the ICP-2 design, which confers extra volume for permeability.

According to Sañudo-Fontaneda et al. (2018) and what has been found in this new research, PC and PA were reported completely clogged after 10 years of performance. These results respond to one of the gaps identified by Razzaghmanesh and Beecham (2018), since no field study was reported to monitor both PC and PA beyond 4 years and only one reached this figure for PA (Winston et al. 2016). Thus, this paper contributes to inform how different PP approach their “end-of-life”.
